MSHA Safety Alert

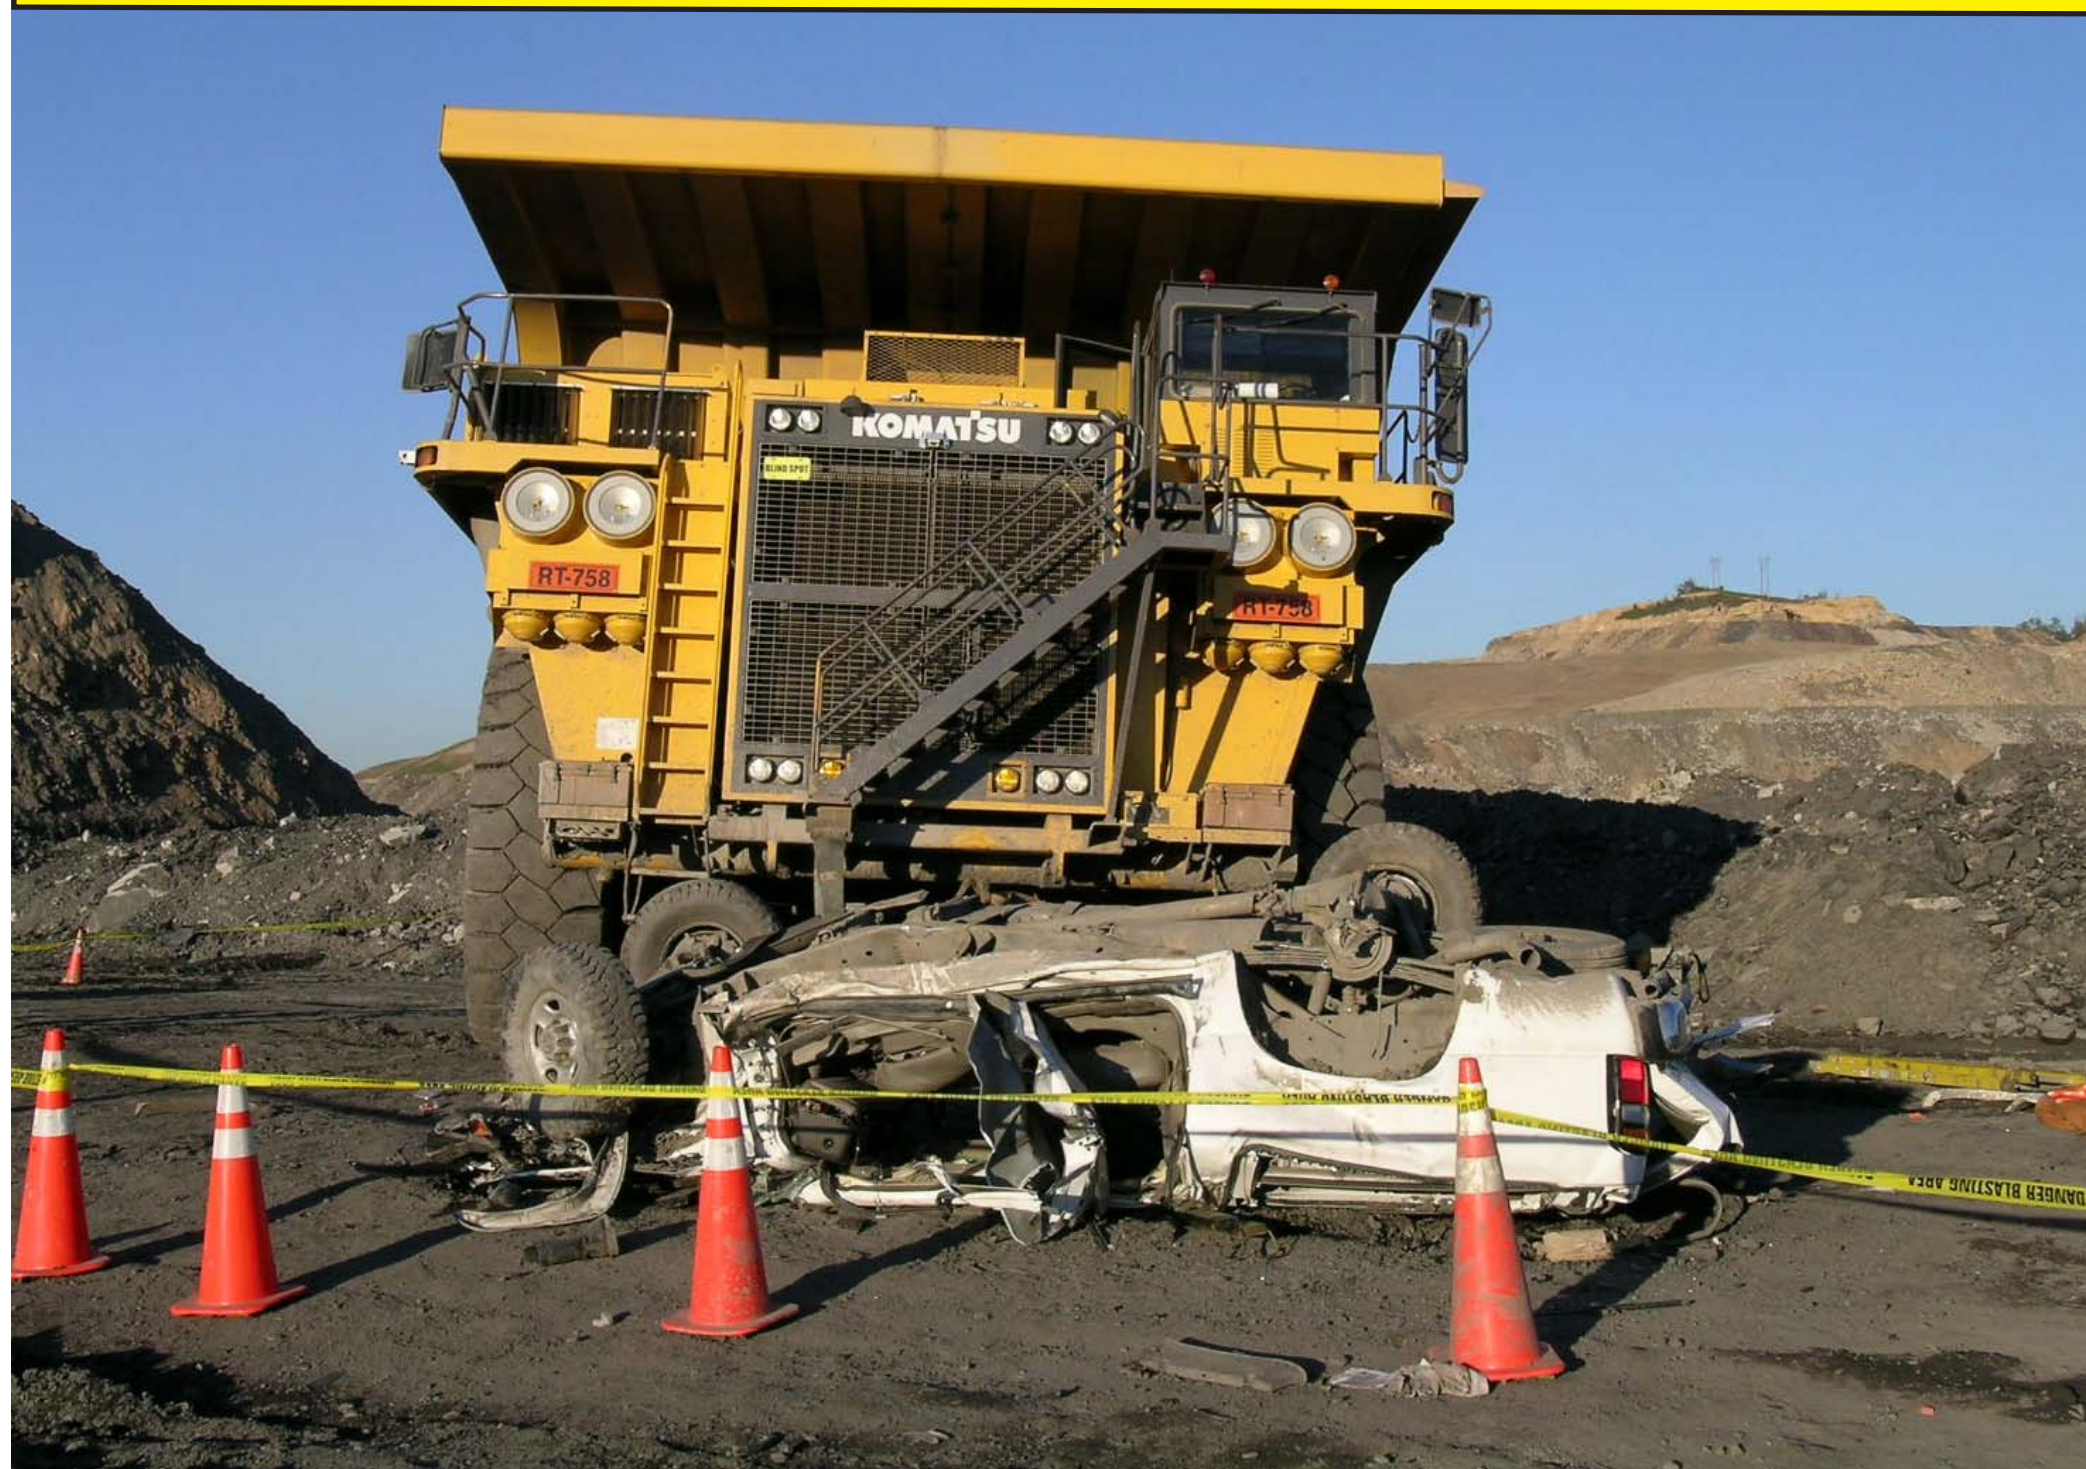
On September 30, 2005, a non-fatal accident occurred when a sport utility vehicle was struck by a large off-road haulage truck. The haulage truck operator had just completed a lunch break, when the truck was loaded and proceeded to leave the loading area. The haulage truck veered to the left, off of the regularly traveled route, and struck the sport utility vehicle. Upon impact, the smaller vehicle rolled over onto its top and became lodged beneath the front steering jacks of the haulage truck. The impact entrapped two persons within the sport utility vehicle. After approximately one hour, the two injured persons were rescued and transported to a hospital where they were treated and released the following day. There were no mechanical problems found with the haulage truck. The sport utility vehicle was equipped with a whip type antenna and a strobe light to increase its noticeability. Substance abuse is suspected as a possible factor in the cause of the accident.

- ✓ Equipment operators must remain diligent, alert, and cautious when small vehicular traffic is present.
- ✓ A minimum radius should be maintained free of equipment around all passenger vehicles.
- ✓ Always alert equipment operators, and wait for a reply, before entering active work areas.
- ✓ Haulage truck drivers should follow designated routes of travel.
